Microscopic investigation of interface  
corrosion of steel-aluminum explosively  
bonded material exposed to periodic sea  
water spray

Keelean, Michael Richard

Monterey, California. Naval Postgraduate School

September 1976

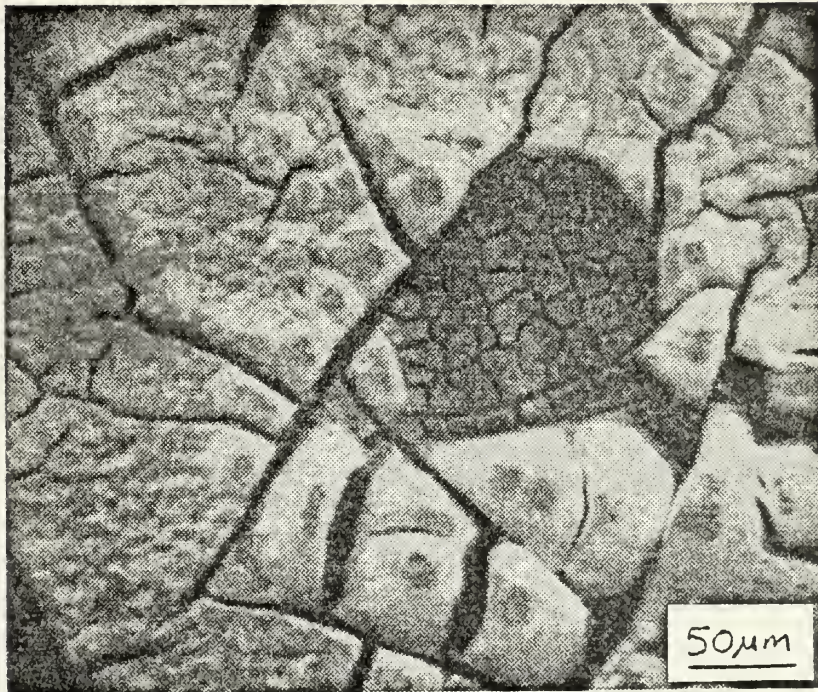
Figure 63. 280x SEM picture of alumina layer beneath second corrosion product film on five-week exposure sample (Steel surface).
